Indonesian Journal of Community Services Cel

## Basic Training on Air Conditioner (AC) Maintenance and Repair for Musala Janitors in Padang City

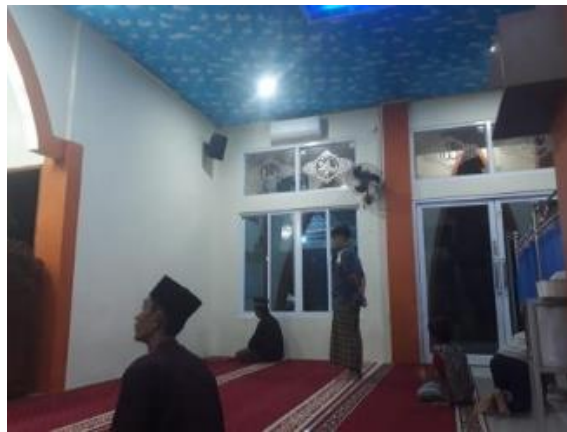
Musala Arafah is one of the places of worship in the Puri Filano Asri Parak Karakah housing complex, Padang. This musala was established independently in 2008 by the residents of the complex. Currently, Musala Arafah is managed by six administrators and two janitors. Musala Arafah has six ACs in good condition (four with 2PK capacity and two with 1PK capacity), four fans, and one 700 Watt sound system. The existence of AC in Musala Arafah is presented in Figure 1

**Figure 1.** The existence of AC in Musala Arafah

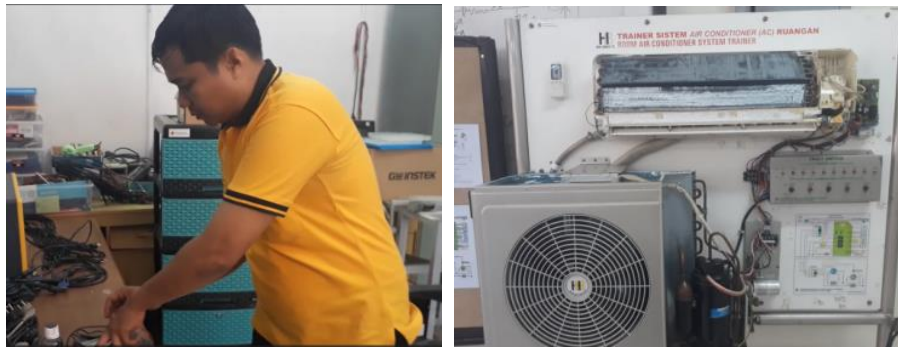
The activity continued on the second day. The chosen location was Maintenance and Repair (MR) Laboratory at the Electrical Engineering Study Program, Padang State Polytechnic based on a reason that this laboratory provides all the necessary equipment and AC training modules. The AC training module used has 10 types of malfunction in indoor system and 5 types of malfunction in outdoor system (Herizon, 2020). The team prepared training materials covering basic theory about AC, its components, routine maintenance, basic repairs, work safety, and work ethics. Mr. Khairul Dasman, S.T. as the laboratory technician in terms of the equipment provider ensured the availability of training facilities, namely classrooms, training tools, and AC equipment needed for simulation and demonstration practices, as shown in Figure 3.

**Figure 3.** Equipment preparation at MR Laboratory, Padang State Polytechnic.

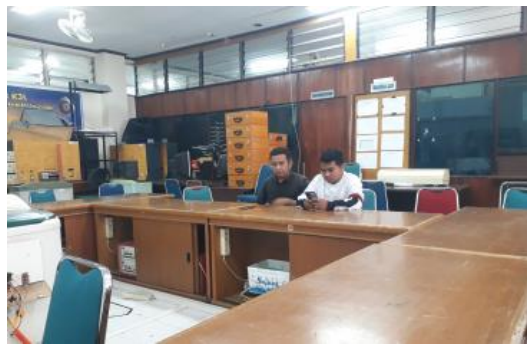
The training on the third day was also attended by the two musala janitors. The trainer team used a projector to provide an introduction and remarks to the participants, also to explain the aims of the training (Figure 4). The team then explained the basic theory of AC, including its working principles, components, and common malfunction symptoms that may occur. The team then deepened the material by explaining routine maintenance, preventive maintenance, and actions that need to be taken when any problem occurs in using AC. The duration of the third day's training was 2 x 60 minutes.

**Figure 4.** Explanation on AC basic theory, repair, and maintenance at MR Laboratory.

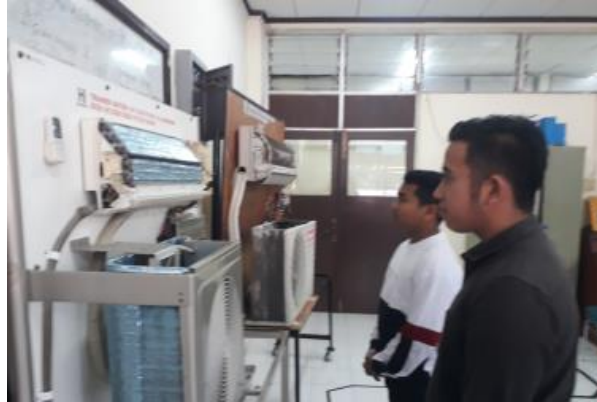
Next, the team gave the opportunity for the participants to practice the malfunction simulation using the AC training module that had been prepared, as shown in Figure 6.

**Figure 6.** Participants practiced the malfunction simulation using the training module.

On the fourth day of training, the trainer team provided guidance and explained the practice steps, while participants observed and actively participated in the material delivery. The duration of the fourth day's training was 4 x 60 minutes. Table 1 presents several cases of malfunction symptoms along with the components that were going to be analyzed as the suspected malfunction cause. The elaboration in the table was explained to the participants as manual for the next step.
